City of Newark, New Jersey  
Feasibility Study

# POLLUTION ABATEMENT PROGRAM

Clinton Bogert Associates  
Consulting Engineers  
September, 1978  
Revised January, 1979

Re: Pollution Abatement

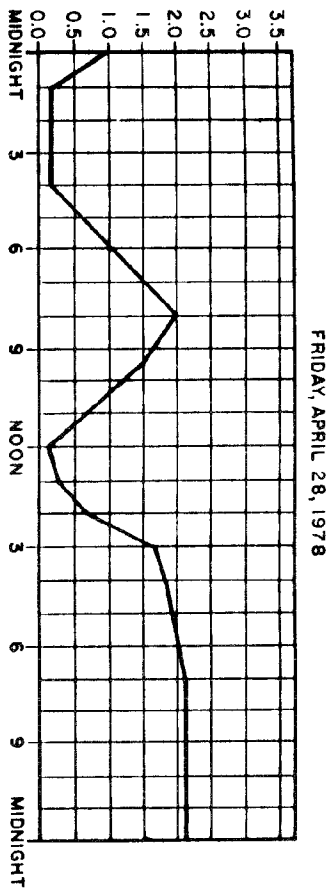
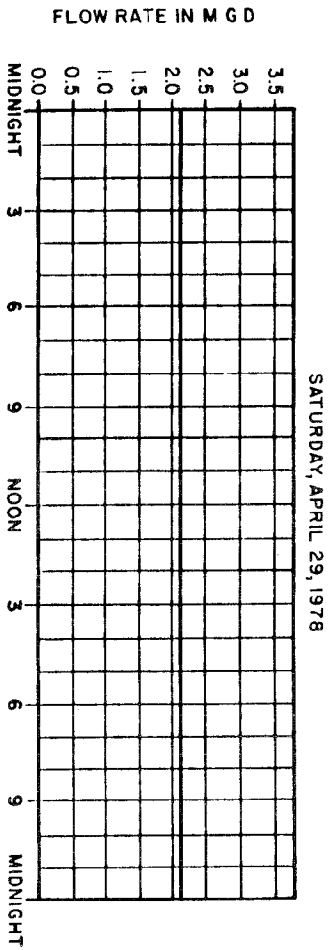
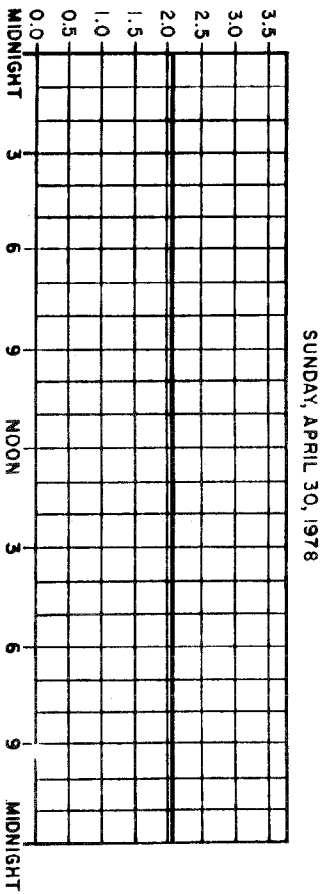
PLATE 3

The flow rates determined in the Roanoke outfall sewer during the period April 24, 1978 to May 30, 1978 are shown on Plates 3 & 4. These rates have been corrected to eliminate tidal effects. Minimum flow rates were found about noon with higher rates in the morning and afternoon. The flow meter data was supplemented by instantaneous measurements obtained before, during, and after the meters were

DIURNAL SEWAGE FLOW PATTERNS  
ROANOKE AVENUE OUTFALL SEWER

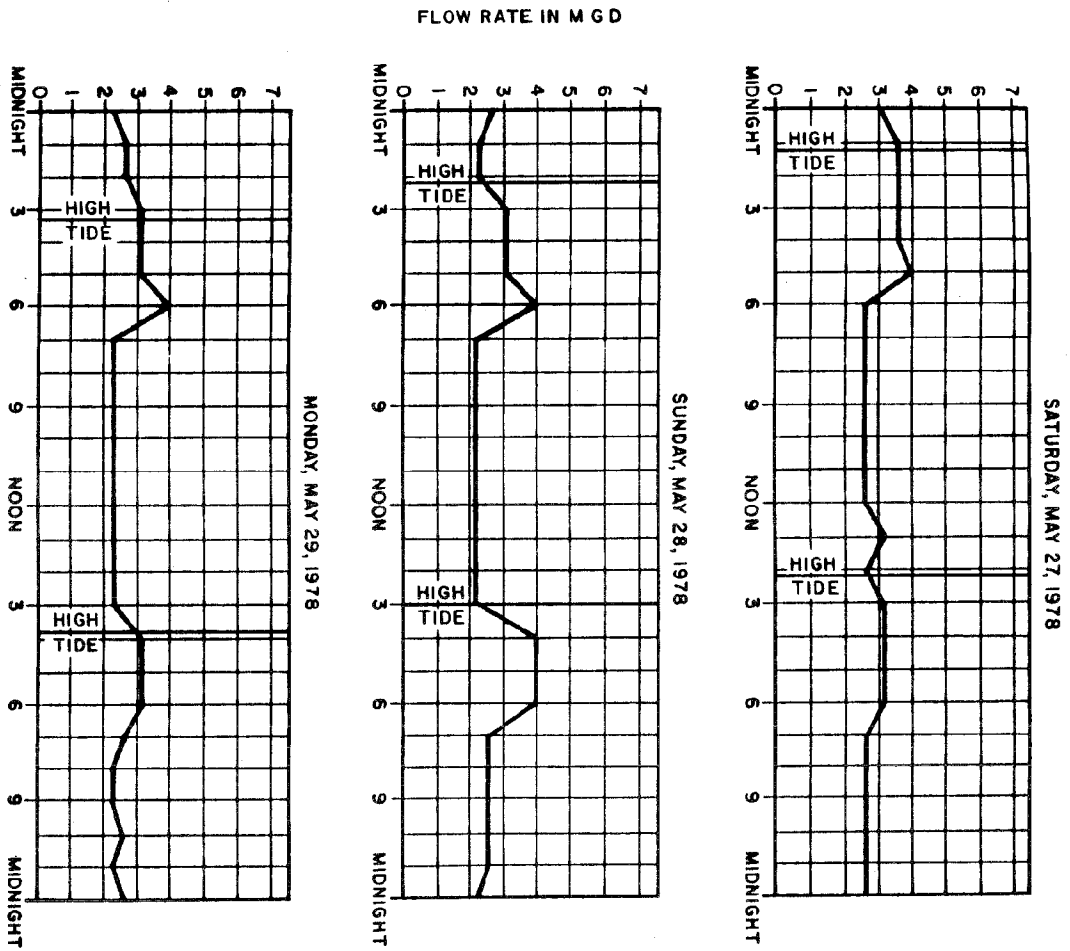
PLATE 8

DIURNAL SEWAGE FLOW PATTERNS  
WILSON AVENUE INTERCEPTOR
